SPC Bell Renovation

April – June 2015

SHEPHERDSTOWN
PRESBYTERIAN CHURCH

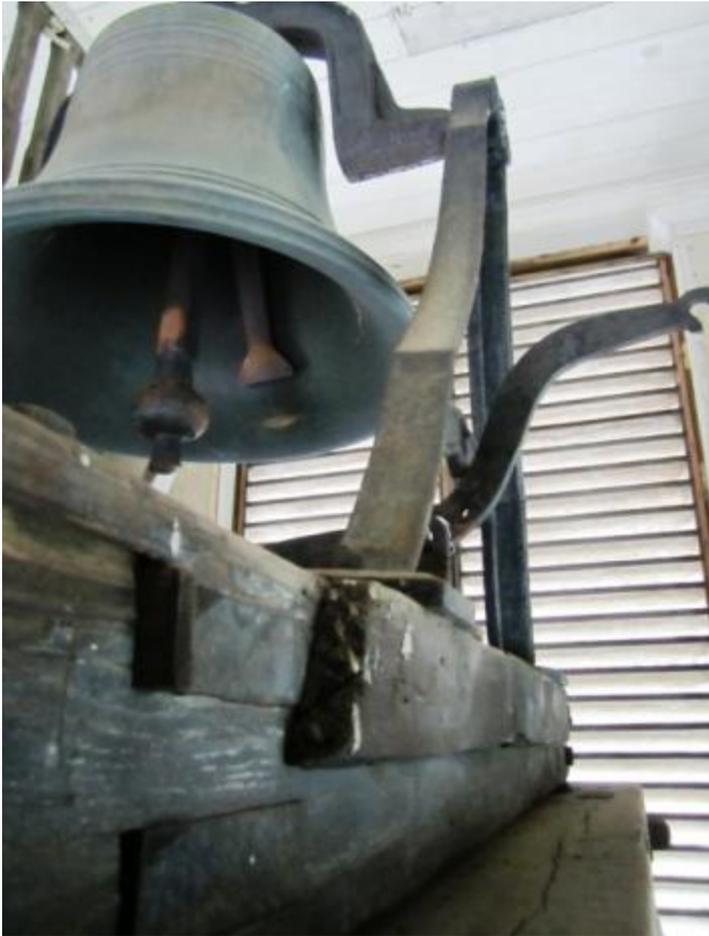
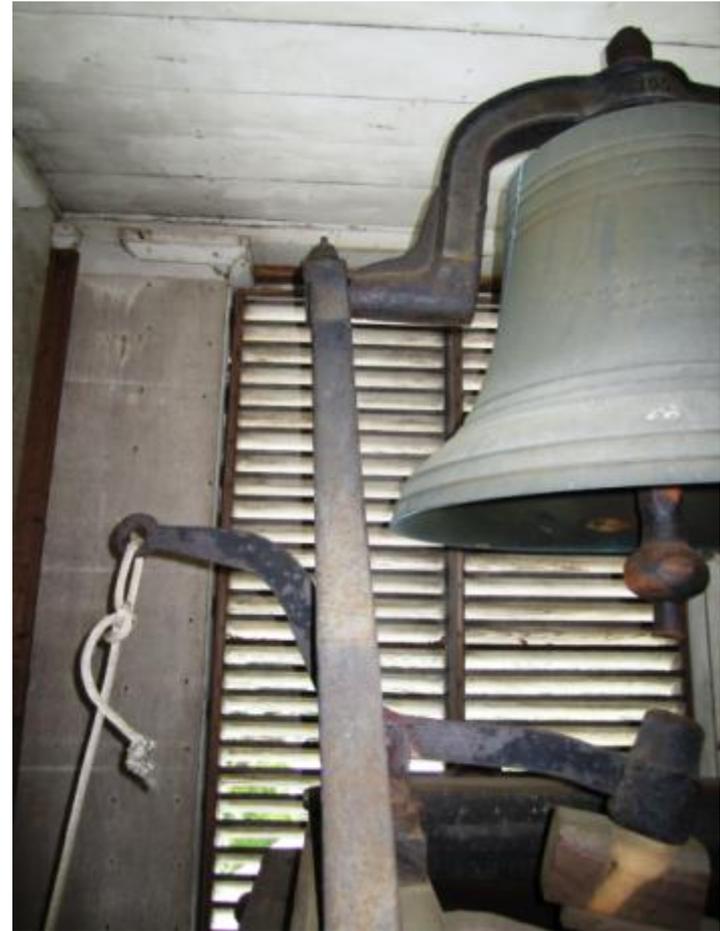
Shepherdstown Presbyterian Church Bell , pre-Renovation
(The wheel side faces West Washington St., the toller faces the sanctuary)

In it's pre-renovation configuration, the stand on the toller side of the bell was partially supported by an "outrigger" 2 x4 . As a result, the stand was not fully seated on the wooden support frame and the entire bell assembly leaned toward the sanctuary.

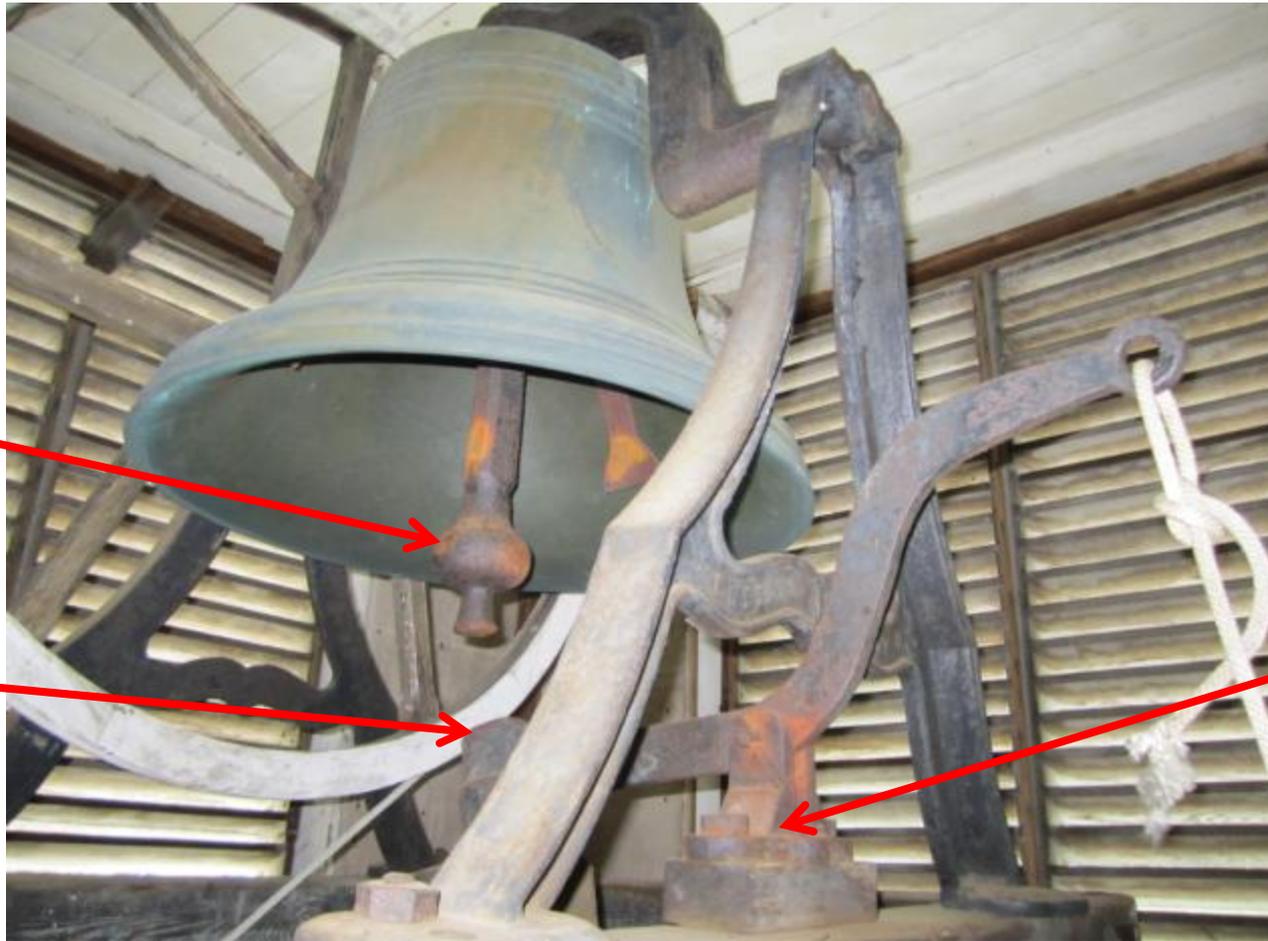
Clapper

Toller
"Hammer"

Toller Base &
Bolts

The bolts securing the troller were loose, making the troller assembly lean toward the bell . This, in combination with the standards, yoke and bell assembly leaning toward the sanctuary (or towards the troller) allowed the troller hammer to occasionally hit and stick to clapper, instead of striking the rim of the bell. For the person ringing the bell several floors below, this feels like the rope was "catching" or "hanging up".

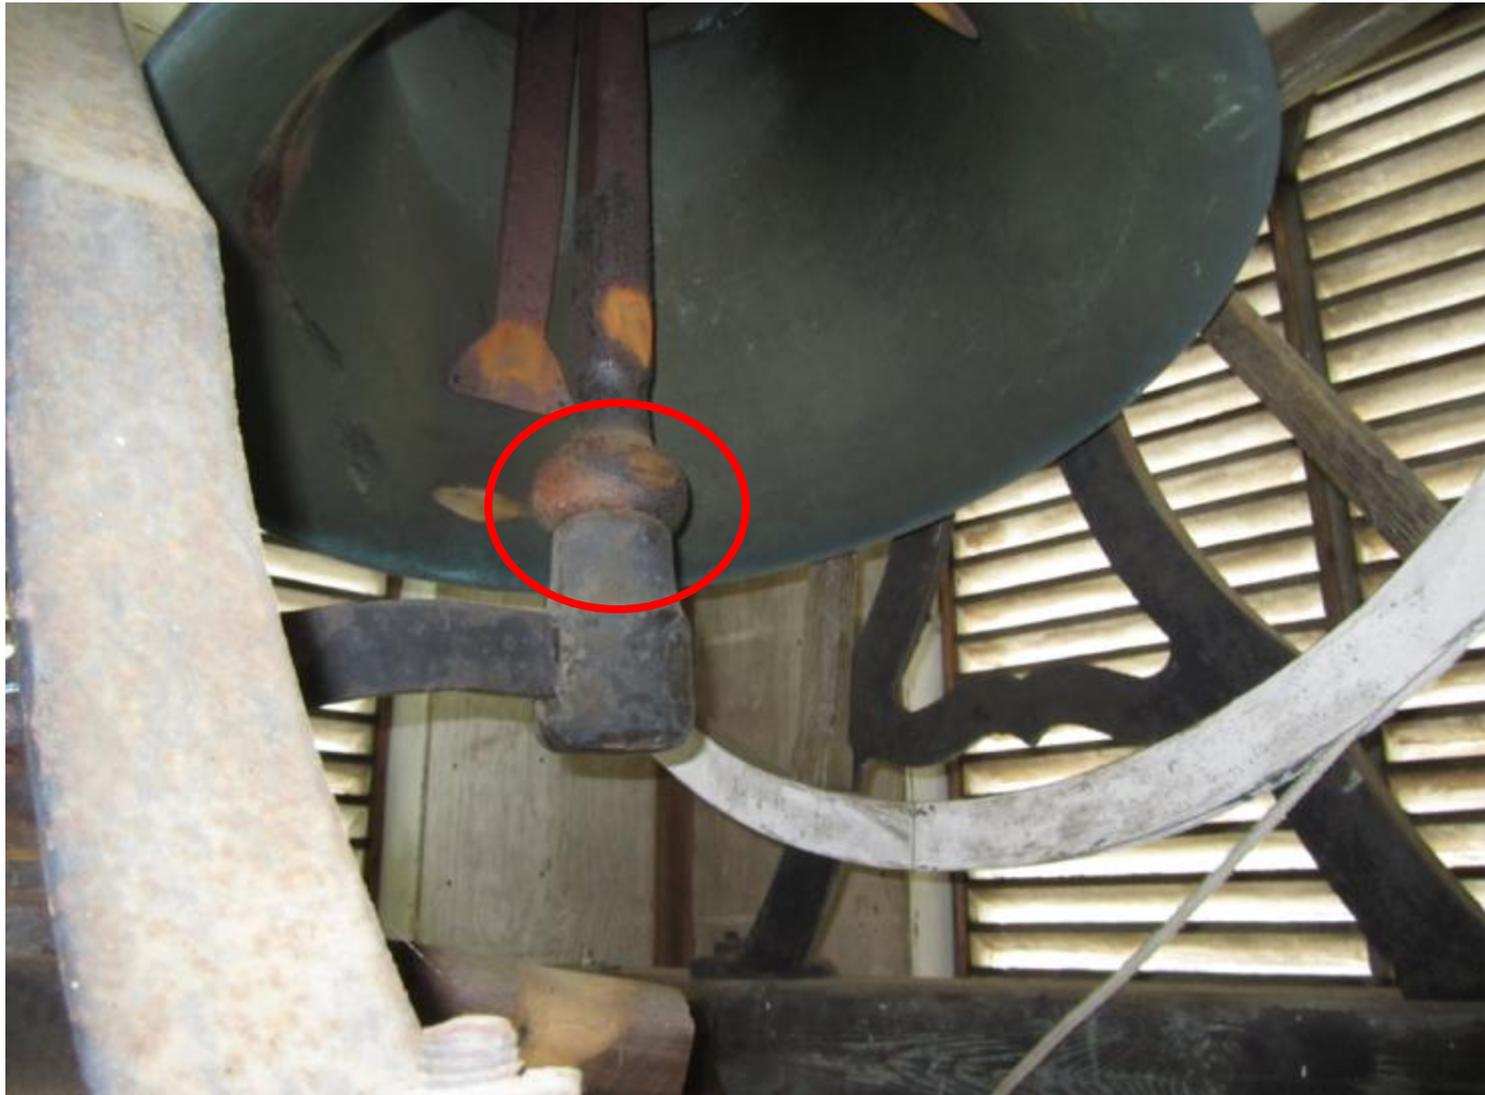
Toller hammer in contact with clapper, instead of the bell

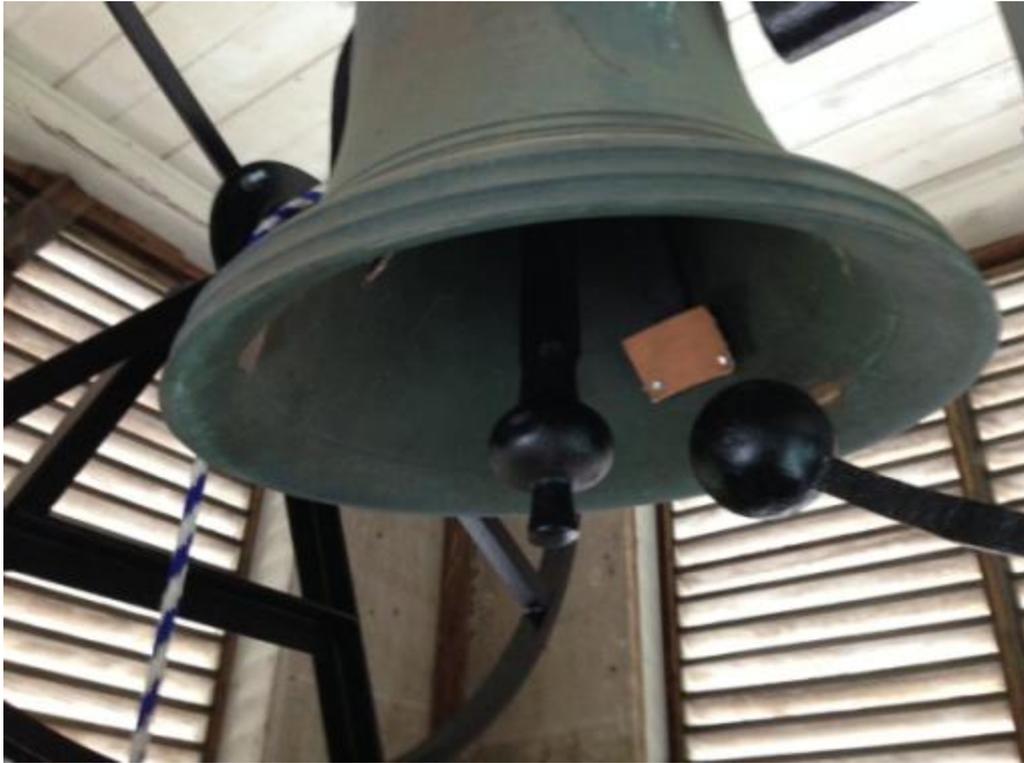
There is now sufficient clearance between the toller hammer and the clapper to prevent “hang-ups”. Note also the leather pads on the clapper spring (to reduce noise when the clapper strikes the spring). The previous leather pads were long gone.
