SPC Bell Renovation

April – June 2015

SHEPHERDSTOWN
PRESBYTERIAN CHURCH

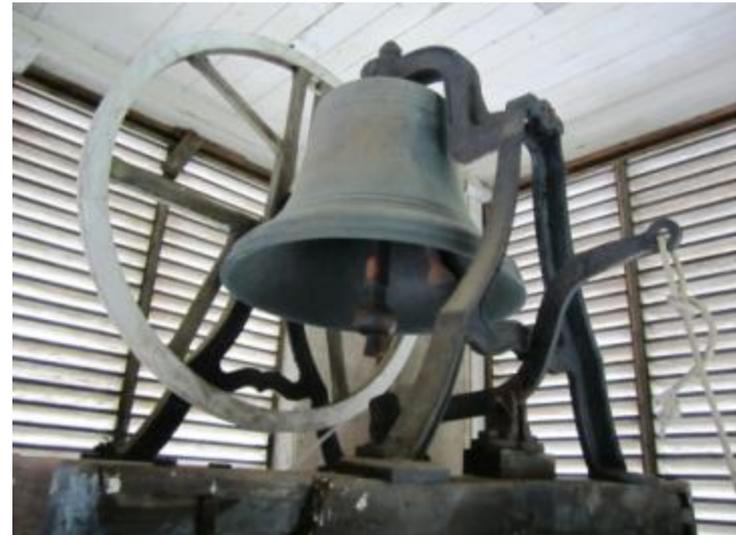
- The bell stand assembly was loose, improperly supported on one side and leaning slightly toward the sanctuary making it unsafe for continued use
- The bell stand assembly was undersized for our 32" bell
- The main support bolt, or clevis bolt, holding the bell to the yoke was loose and worn, causing excess vibration when the bell was swinging
- The toller hammer assembly was oversized and loose. When combined with the "leaning" described above, the toller hammer frequently "hung up"
- The yoke/stand bearing assemblies were worn
- The wooden wheel was weak

- New stands and adjacent wood frame supports
- New clevis bolt to attach bell to the yoke
- New bearings
- New toller hammer, sized for the our bell
- New steel wheel
- New leather pads on the internal clapper spring
- And more...
